**Particle Physics Division
Mechanical Department Engineering Note**

Number: MD-ENG-03-008

Project: NuMI

Title: Setup to rip (cut lengthwise) long CCSS slabs and protect personnel during a release of stored energy if a slab fractures while being cut

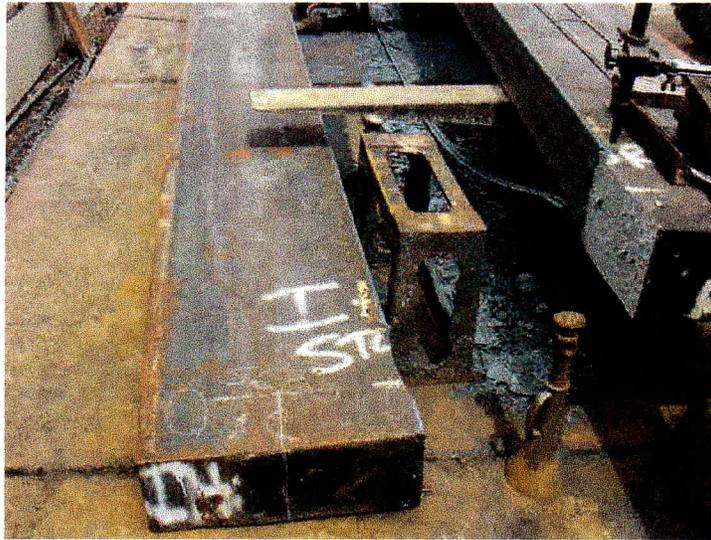
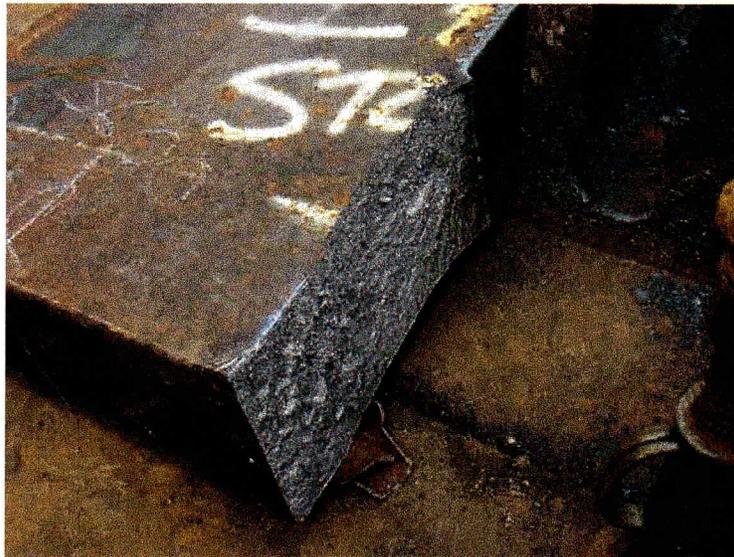
On Friday, May 30, 2003, a welder of the Technical Division Machine Shop group was cutting a 9.11"x19'4"x49", 29,000lb piece of steel using a MAPP gas and Oxygen cutting rig at the Railhead. The steel was supported by magnet stands and bottle jacks approximately 18" off of the ground (Figure 1). The cut was along the length (19'4") of the steel creating two equal pieces. Approximately 16" from the completion of the cut, the steel fractured and one 9.11"x19'4"x24.5", 14,500lb piece of steel fell 18" to the ground. No one was injured and the only property damage was a broken bottle jack.

When cutting, the media gradually bows due to heating and cooling. This created a "pinch point" or pressure point in the steel, which is exaggerated in Figure 2. This is a normal phenomenon according to the welder involved. Near the completion of the cut, the pressure increased resulting in the fracturing of the last 16" of steel. The magnet stands and bottle jacks failed to support the release of lateral energy created when the steel fractured.

Another condition that may have contributed to the incident was the magnet stands and bottle jacks were not adequate to support the steel in case an event such as this one occurred.

- The magnet stands and bottle jacks could not support the release of lateral energy, though they were adequate for the amount of vertical force.
- A Job Hazard Analysis was written, but did not include provisions for this type of incident.
- “Pinch points” occur when cutting steel, especially with longer cuts.

- Contact the vendor of the steel and be sure that the grade of steel will be adequate for the operations and tasks.
- Consider engineering reviews whenever a job is being performed with unpredictable materials.
- Write JHA's carefully to include all possible hazards.
- Be sure supports are adequate and can account for unpredictable occurrences such as the fracture force from a "pinch point."
- Be aware that "pinch points" can and do occur when cutting steel, especially longer cuts.
